RAVEN INDUSTRIES, INC.

SUBJECT: Service Bulletin No. 116

SERVICE BULLETIN 116

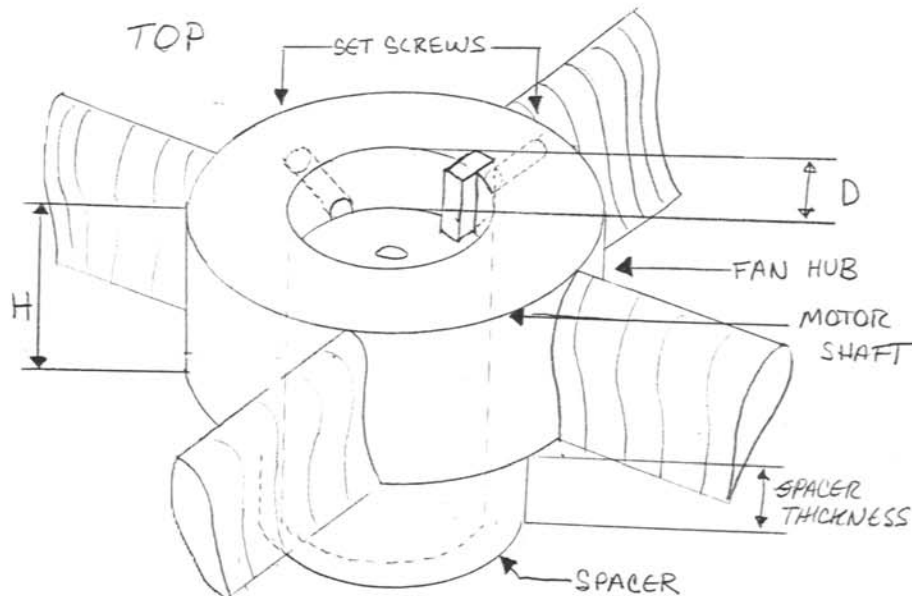
The supplier of the fan for this system has modified the fan hub dimensions slightly without any notification. The dimension change is pictured on the enclosed service bulletin as dimension "H" which was originally 1.45 inches. This change makes the thickness of the spacer very critical.

With the original 1.45 inch fan hub, the original spacer (.55 inch) brought the upper face of the fan hub flush or nearly flush with the motor shaft. The more recent fan hub with the .55 inch spacer brings the upper face as much as 3/8 inch above the motor shaft end. Consequently, it is possible that the hub set screws will only contact partially with the motor shaft end key. This means the fan could come loose over a period of time.

SUBJECT Superpressure Blower**APPLICABILITY** Raven Burner Models HP2C-101 to 164**PROBLEM** Change in dimension of fan hub affects position of upper face fan hub to motor shaft.**CORRECTIVE ACTION**

1. Remove blower assembly from burner.
2. Remove 10 cap screws which retain upper screen on top side of blower. Remove screen.
3. Using above illustration as a guide, measure distance D , shaft depth. If this distance is greater than $3/16$ inch, proceed to step 5.
4. If distance D is $3/16$ inch or less, the fan hub distance H is nominally 1.45 inches which is acceptable. Fill out the blower card and check the box marked "Spacer not required." Replace the blower screen and snug the cap screws. Please return the card to Raven.
5. If distance D is greater than $3/16$ inch, fill out the blower card and check the box marked "Spacer required." If rapid service is needed, call Raven and request a new spacer. It

6. Remove fan and hub. This may be done first by loosening two set screws several turns and then using a puller, such as a gear puller, steering wheel puller or another type.
7. Remove the old spacer and replace with new spacer. Replace fan, hub and key. Tap hub gently with a hammer to seat the assembly onto the spacer. (Check to be sure the fan blades do not hit the motor mount bolt-heads during rotation.) Tap key gently into place so it is flush with the face of the hub. Tighten set screws and replace upper screen and cap screws.
8. Please return the "Work Performed" card to Raven with the appropriate information.
