AEROSTAR
SERVICE BULLETIN #121

28 July 1986

SUBJECT Ball Pyrometer Infrared Sensitivity

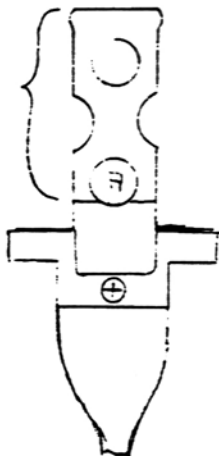
PROBLEM The Digital Pyrometer which is part of the Ball 655R instrument package has been determined to be susceptible to abnormally high readings due to radiant infrared heating during burns.

Coat Nominally
1 inch with White
Titanium Dioxide

CORRECTIVE ACTION The sensitivity to infrared heating can be substantially reduced by coating the sensor with a titanium dioxide white paint. Titanium dioxide based white provides the greatest re-radiation or reflection of infrared heat available. Testing has indicated this does not adversely affect the response time of the sensor.

Step 3: Fully coat the sensor as shown in the following diagram. Ensure that the thermistor which is contained inside the protective shield is fully coated but is not left with an excessively thick layer of paint.
