## AEROSTAR SERVICE BULLETIN 130

02/20/92

**Subject:** Replacement of aluminum support tubes on Classic Limited Stretch (CWS) gondola (P/N 51620) or Classic Limited (CW) gondola (P/N 13860) or Classic Custom (CWV) gondola (P/N 15325).

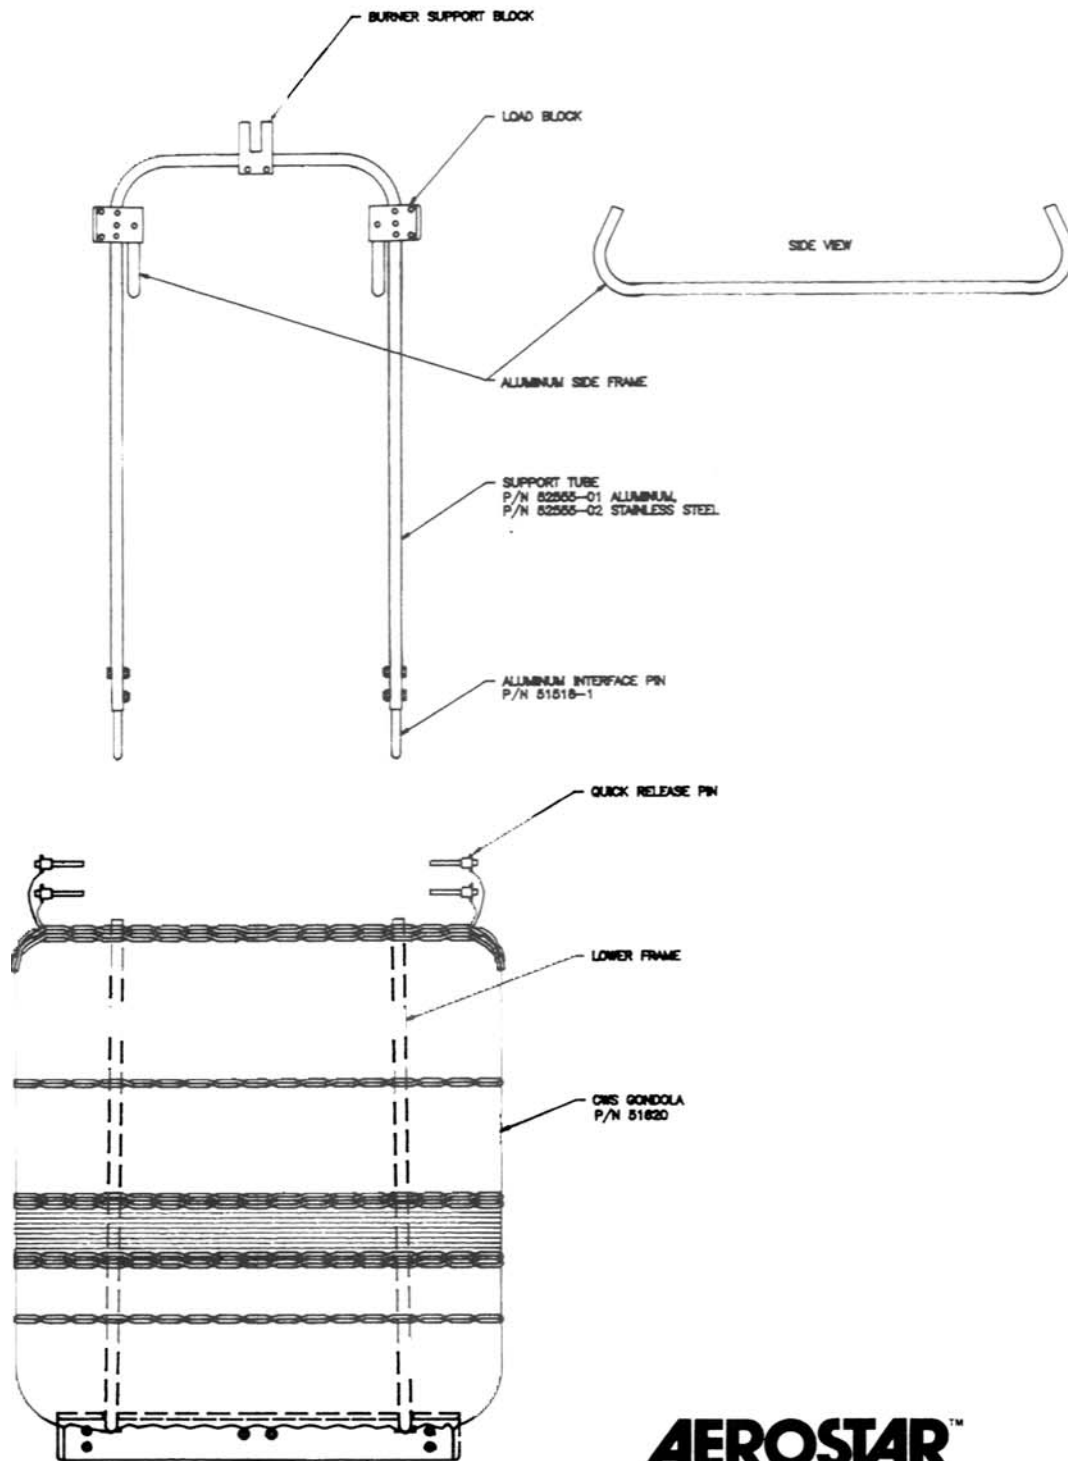
Note: See Figure 1, Page 5

**Problem:** An S66-A balloon mated to a Classic Limited Stretch basket recently experienced a stress fracture on the aluminum superstructure support tube at the lowest hole on the load block.

- 1) Install aluminum support tubes in basket. It is imperative that the support tubes be installed in the basket to ensure a proper match and alignment of the aluminum interface pins during reassembly.
- 2) Insert quick release pins, fastening lower frames to support tubes.
- 3) Leaving quick release pins which connect basket and superstructure support tubes installed, remove bolts at bottom of support tubes. Remove support tubes from aluminum interface pins, leaving interface pins installed in lower frames.
- 4) Remove bolts which attach load blocks to aluminum support tubes (3 each load block) and remove load blocks.

- 5) Remove burner support block from aluminum support tube.
- 6) Install burner support block on stainless steel replacement support tube. Refer to P. 4-40a of ACAI manual.
- 7) Install load blocks on stainless steel support tube.
- 8) Place new support tubes on aluminum interface pins still installed in lower frames. Be sure to push support tubes down as far as possible. Install aluminum side frames, completing superstructure assembly.
- 9) Reinstall bolts connecting stainless steel support tube and aluminum interface pin.
