AEROSTAR SERVICE BULLETIN #133

DATE OF ISSUE: AUG 23 1994

SUBJECT: *All Baskets with 4-Point Aluminum Superstructures*

APPLICABILITY: *RWS baskets S/N 101-598
CW baskets S/N 3025-3115
CWS baskets S/N 3033-3104
Any baskets retrofitted with a 4-point aluminum superstructure.*

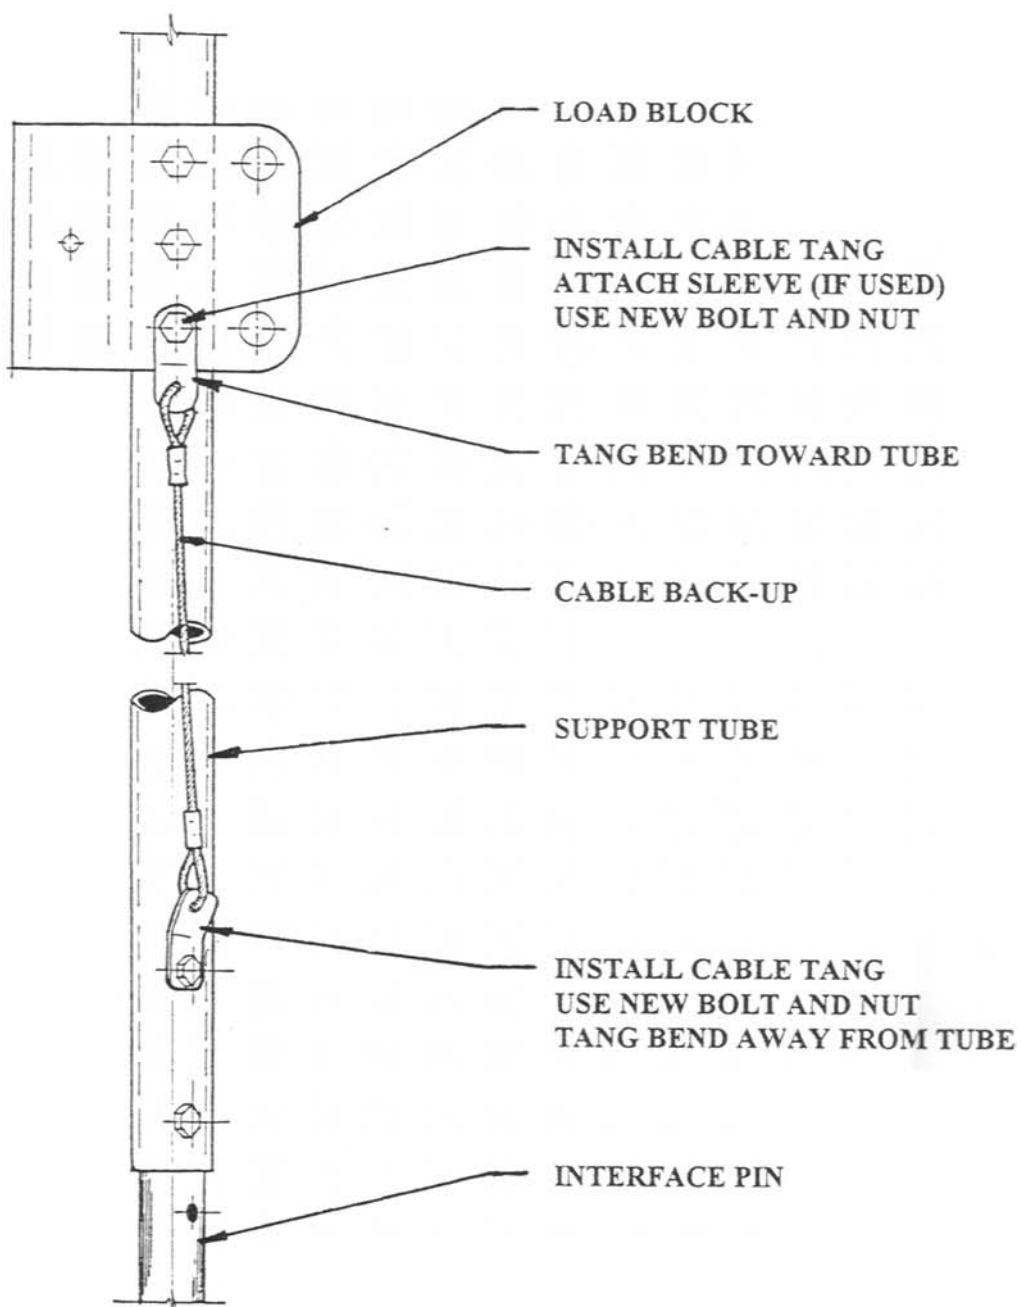
Figure 1 Cable Redundancy Installation

PROBLEM: *Aluminum support tubes on 4-point systems may be susceptible to damage normally hidden by the load block. Contributing factors may include metal fatigue and unusual torque forces on load fittings induced during inflation tie-off and/or tether operations. This can result in highly concentrated localized stresses in the support tube.*

DISCUSSION: *In a very limited number of instances one or more support tubes have failed at the bottom bolt hole of the load block fitting. The occurrence is more common in high-wind inflation tie-off, or high-wind tether situations which exert a rotational torque on the load block fittings. Further investigations have revealed evidence of fatigue fractures and fretting around the bolt hole prior to failure.*

CORRECTIVE ACTION: *A cable back-up redundancy system is to be installed in accordance with the enclosed procedure and utilizing a factory supplied parts kit.*

For systems without upright covers (leather or cordura), a cordura sleeve will be provided to cover the support tube and cable.
