AEROSTAR SERVICE LETTER 103

11/01/90

- Subject:** Springtop paravent modification
- Applicability:** Aerostar RX-7; Date of manufacture from 5/86 to 11/90.
Aerostar RX-8; All models manufactured before 11/90.
S55-A, S57-A, S60-A; Date of manufacture from 9/88 to 11/90.

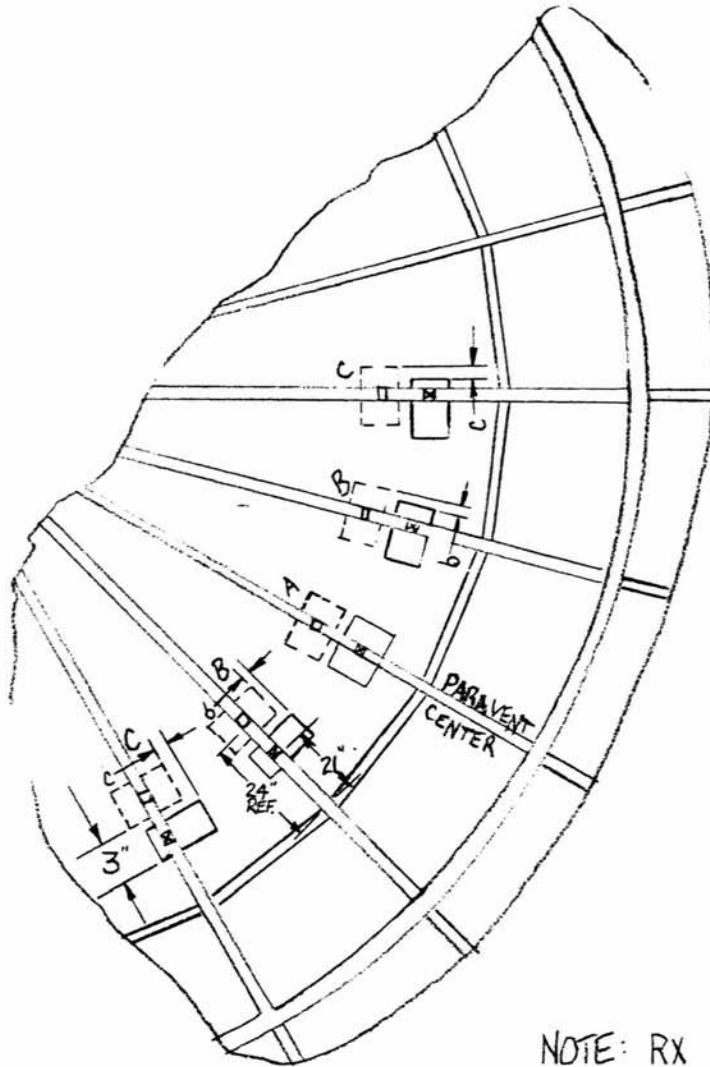
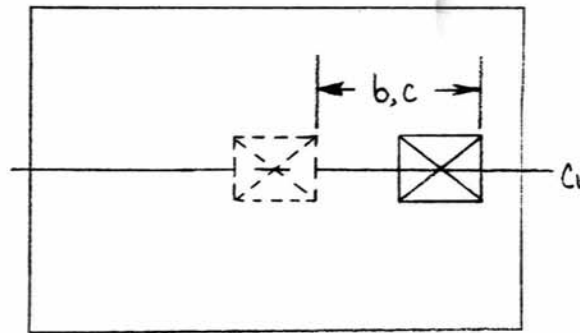
FIGURE

- Problem:** Recent field reports have indicated that a very small number of Springtop paravents have not been sealing completely, resulting in higher than normal fuel consumption rates.

- Discussion:** This problem is related to changes which occurred during Springtop standardization. The alteration of certain dimensions may have made the fit of the paravent more sensitive to shrinkage and/or elongation of the top-cap fabric. Although these balloons did not leak when they left the factory, normal use may have resulted in shrinkage and/or elongation of the top-cap fabric causing minor leaking or stress in the vent area in a limited number of cases.
This modification is not required, and is probably not necessary for the majority of balloons in service. However, if the operator has experienced

- 1) First, verify that the distance from the box-x (connecting overstrap to top-cap) to the first circumferential "spider web" in the port along the radial measures 24 in. +/- 1 in. (See Fig. 1) If this dimension is not met, the balloon is not affected by this service letter.

- 2) Measure three inches radially outward (towards the port edge) from the box-x location on the overstrap, and make a mark. (3 locations RX series, 5 locations S series).

- 3) Carefully remove the box-x stitching which connects the overstraps to the top-cap.
- 4) Refer to Figure 1. Except for the center (A) reinforcement patch, the box-x is not re-sewn to the middle of the patch, but is offset as shown. The object of this offset is to preserve the fullness in the vent area of the top-cap; thus the patches are moved towards the center of the vent. Identify each patch as (A), (B), or (C) and mark the offset on the patch.

- 5) Using a single needle machine with "F" thread, (6-9 stitches/in., thread type V-T-285 polyester, Type I or II, Class 1 or 3), sew a box-x connecting the top-cap to the overstrap at the marked locations.
